Albert & Isabelle Wilford House
6754 Montgomery Road
Private

Historic Properties Form

Inventory No. HO-1032

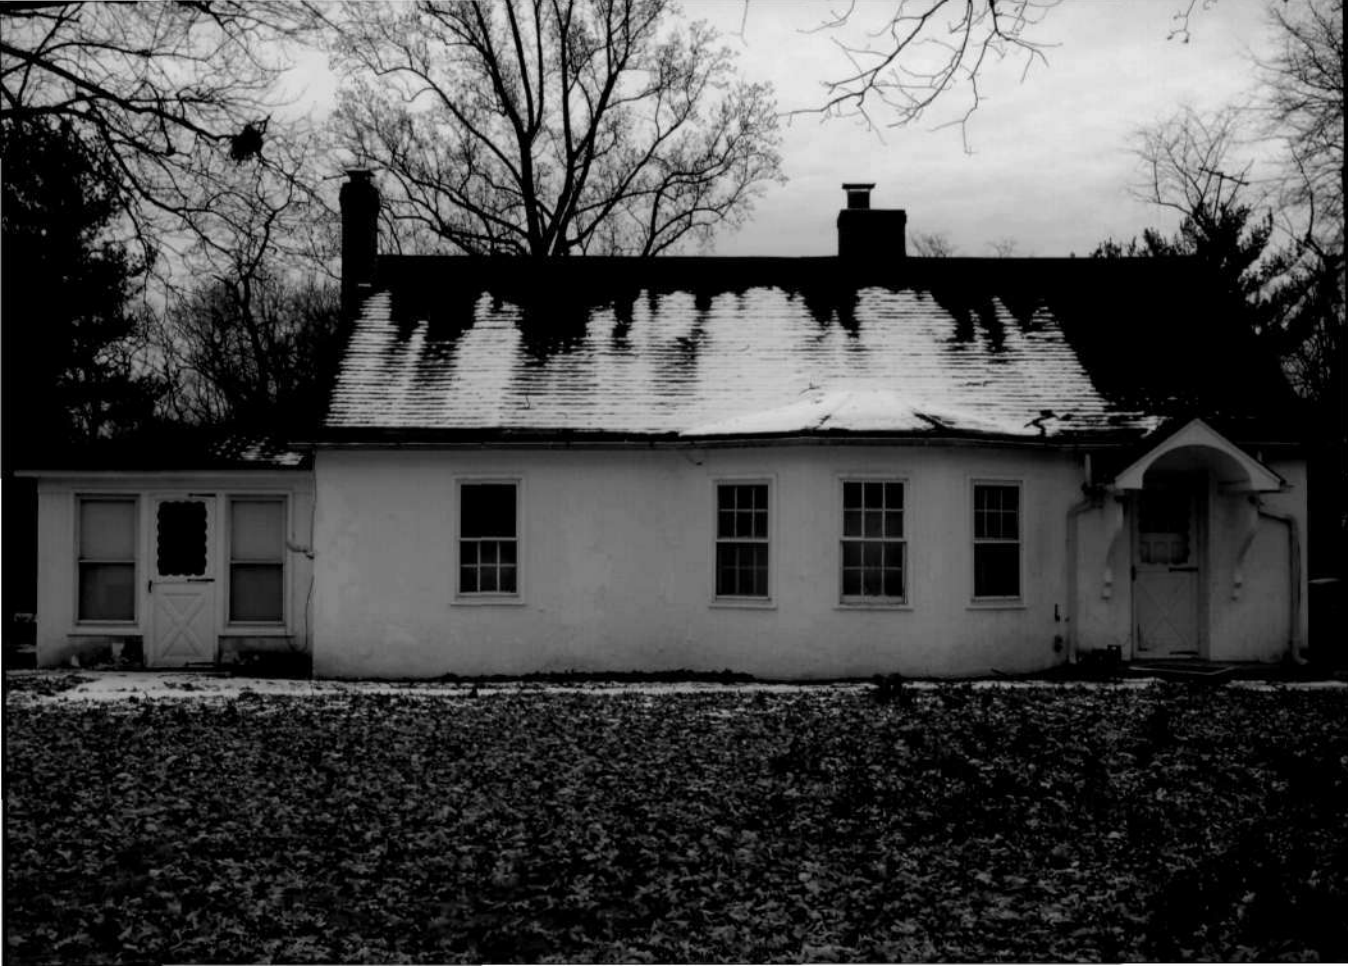
1 of 4

HO-1032_2010-12-22_01
North elevation

North elevation

The north elevation of the main block has a six-over-six sash in the east bay, a projecting three-sided bay window in the center that has a six-over-six sash in each side of the bay, and a doorway in the west bay. The door here has six lights over three tall panels. There is a gabled hood above the doorway, set on two very large scroll brackets. The cornice is boxed. The north elevation of the porch has a door in the center with nine lights, and has a one-over-one sash to each side.

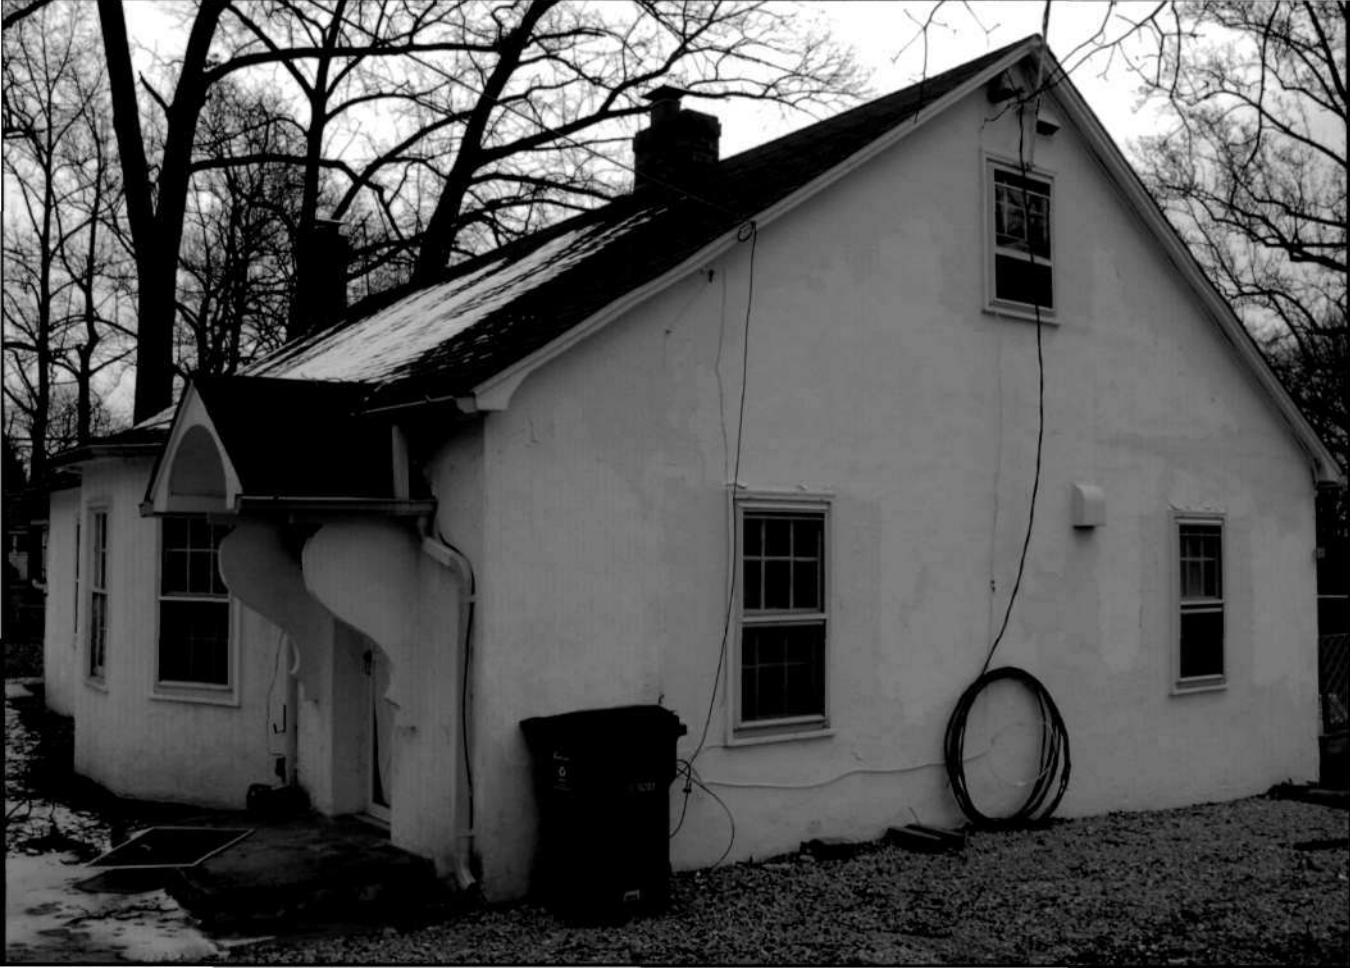
2 of 4

HO-1032_2010-12-22_02
North & west elevations

North + west elevations

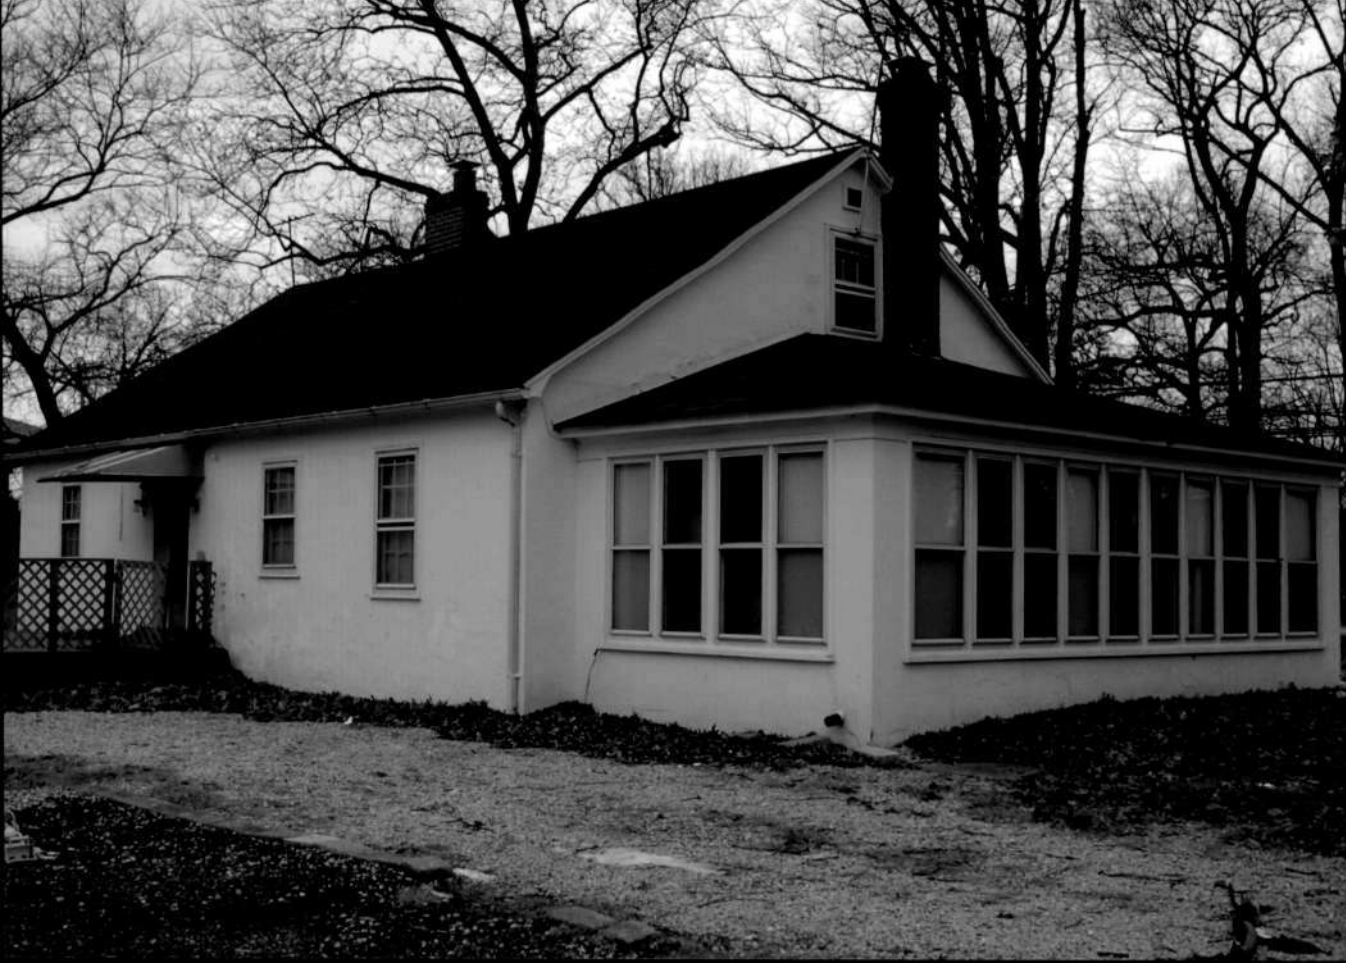
3 of 4

HO-1032_2010-12-22_03
South & east elevations

South + east elevations

The east elevation of the porch has a bank of ten one-over-one sash. The gable end of the main block has a six-over-six sash. The south elevation of the porch has a bank of four one-over-one sash. The south elevation of the main block has six-over-six sash in the west, east-center, and east bays, with a doorway in the west-center bay that is missing its door.

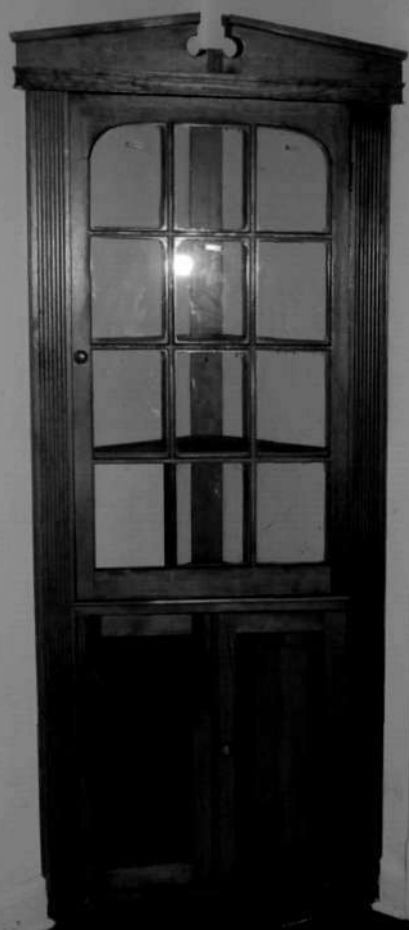
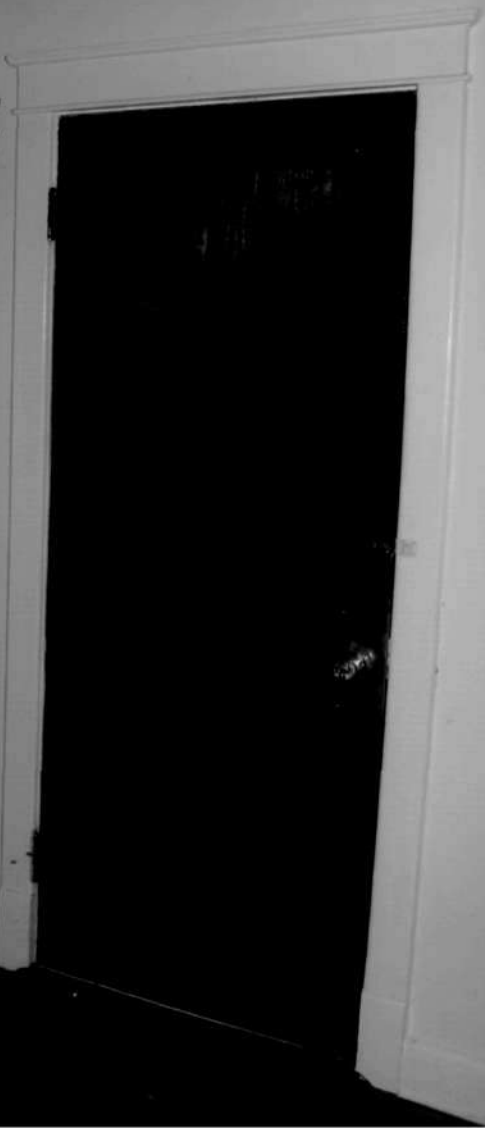
4 of 4

HO-1032_2010-12-22_04
Northwest room, vw. northwest to front door
& corner cupboard

Northwest room, vw. northwest to front
door + corner cupboard

The Living Room has a fireplace centered on the south wall with a brick mantel and a built-in bookcase to the east; the moulding at the top of the bookcase is carried across the top of the mantel. In the northwest corner, nest to the door, is a wood corner cupboard with two one-panel doors at the bottom and a 12-light door at the top. The cupboard has fluted pilaster strips and a broken pediment.
